SCE Aircraft Operations Flight Request Form

06-08-2020	<u> </u>	Notification Over	rview RE	EDMM	Сору	Page 1 of 3	
Notification	410413114	· · ·			Notification Typ	e E1	
Subject Matter	EZ-ELEV	0010	Distribution P	rimary			
Description	•						
Reporter	SAMUELJ		1:58:37 PM		Notification Date	e 10-12-2019	
Start Date	10-12-2019				End Date	04-12-2020	
Start time	9:20:00 AM				End time	11:59:00 PM	
Priority	EA 2		Priority 2				
Funct Location	OH-831522E	Į.	POLE-DISTR	IBUTION	831522E LOCATION		
Location Descri	iption		SPRR PP 74	70'N E/S	W LINE RNCHO CANADA	A SN MIQUELIT	
City	VENTURA						
Thom. Guide							
Equipment	207436789		POLE-DISTR	BUTION	831522E		
Circuit Name	ED-07480		GRANDAD				
Order	902988947		Operation No	. 0010	114052E	· · · · · · · · · · · · · · · · · · ·	
Room	6039						
Plant Section	239		D- Ventura				
Sort field	831522E						
PM Planner Gro	oup 239	Ventura S/0	;	Phor	ne		
Detail Position	0001			Text			
Object Part	0032	Hardware/F	raming	Erro	r Class

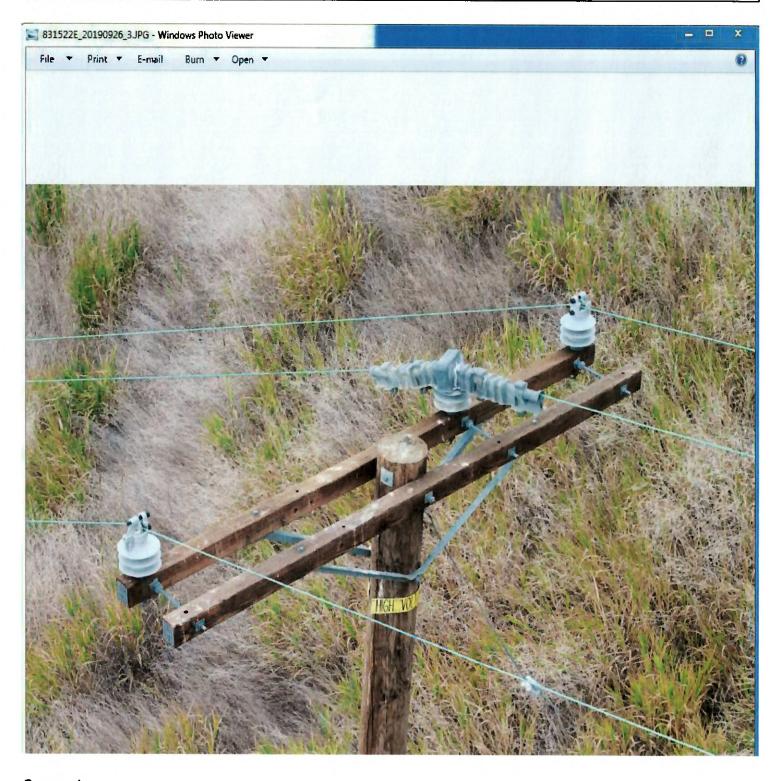
Damage	0022	Damaged/B	roken	Asse	embly		
Task	Repair			Worl	center 21N39	Ventura Default Work Cente	
Cause of Dam	age						
Cause Text							
Cause of Dama	age Code			Actio	on Taken Code [
10/15/2019 01:53:20 PST CMSPIWSUSER (CMSPIWSUSER) Jason Samuelson * 10/15/2019 01:52 * EOI/OFF CYCLE INSPECTION – AERIAL INSPECTION, EXTREME, Inspected 10/12/2019by SAMUELJ1, , Reviewed 10/14/2019by ALLENWT, Insulator shear ring backing out 12/02/2019 12:07:44 PST M. Moreno (MORENOMJ) Phone 805-654-7408 79408 FIELD CHECK IF BAD INSULATOR. REPLACE IF NEEDED. —————————————————————————————————							
Comments							
			·-
